Manhole Inspection Summary

Manhole # S3100_001MH

Insp Date: **4/25/07 10:13 AM**

Location Address: **400 HAMDEN ST**

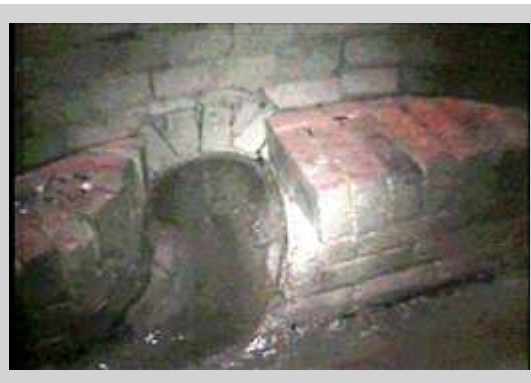
Drop In @ 3 O'Clock

Infiltration: **Evidence** Pipe Seal Cond: **Unknown**

Drop: **Outside** Rod and Bar

Angled: **Yes** Reading: **17.43** (ft.)

Drop Condition: **Open**
